An Analysis of the 2017 Rock Avalanche and Debris Flows at Pizzo Cengalo, Switzerland (with a short update on the Illgraben force plate)

Brian W. Mc Ardell with contributions from: S. Demmel, M. Christen, P. Baer, F. Frank, P. Molnar, P. Bartelt, F. Amann,

Swiss Federal Institute for Forest, Snow and Landscape Research

Early warning systems for debris flows: state of the art and challenges Bozen-Bolzano, October 16-18, 2019

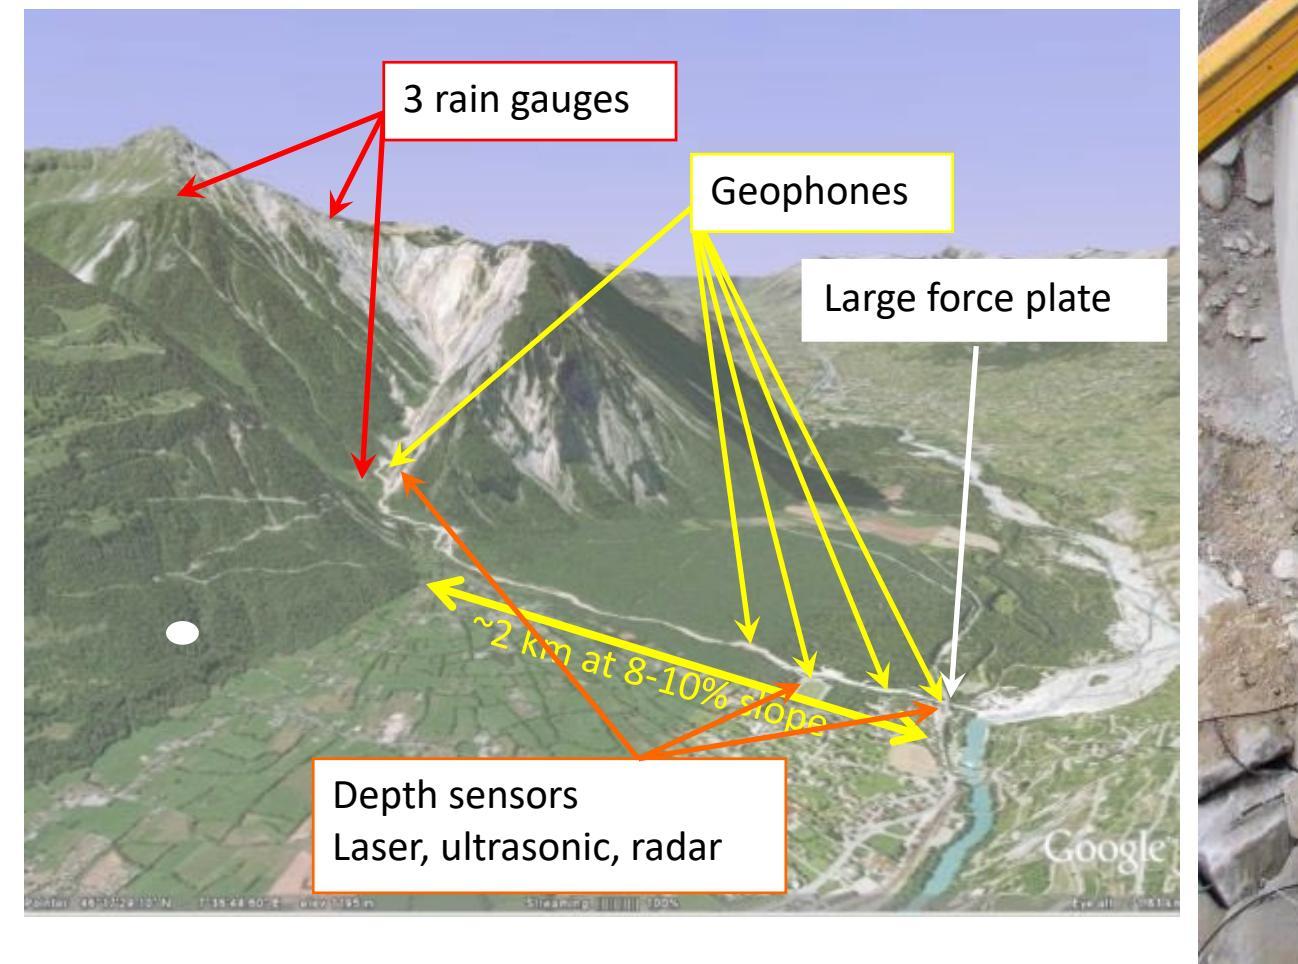
Destruction of the force plate on 22.07.2016

Re-designed:	2017-18
Re-installed:	2019

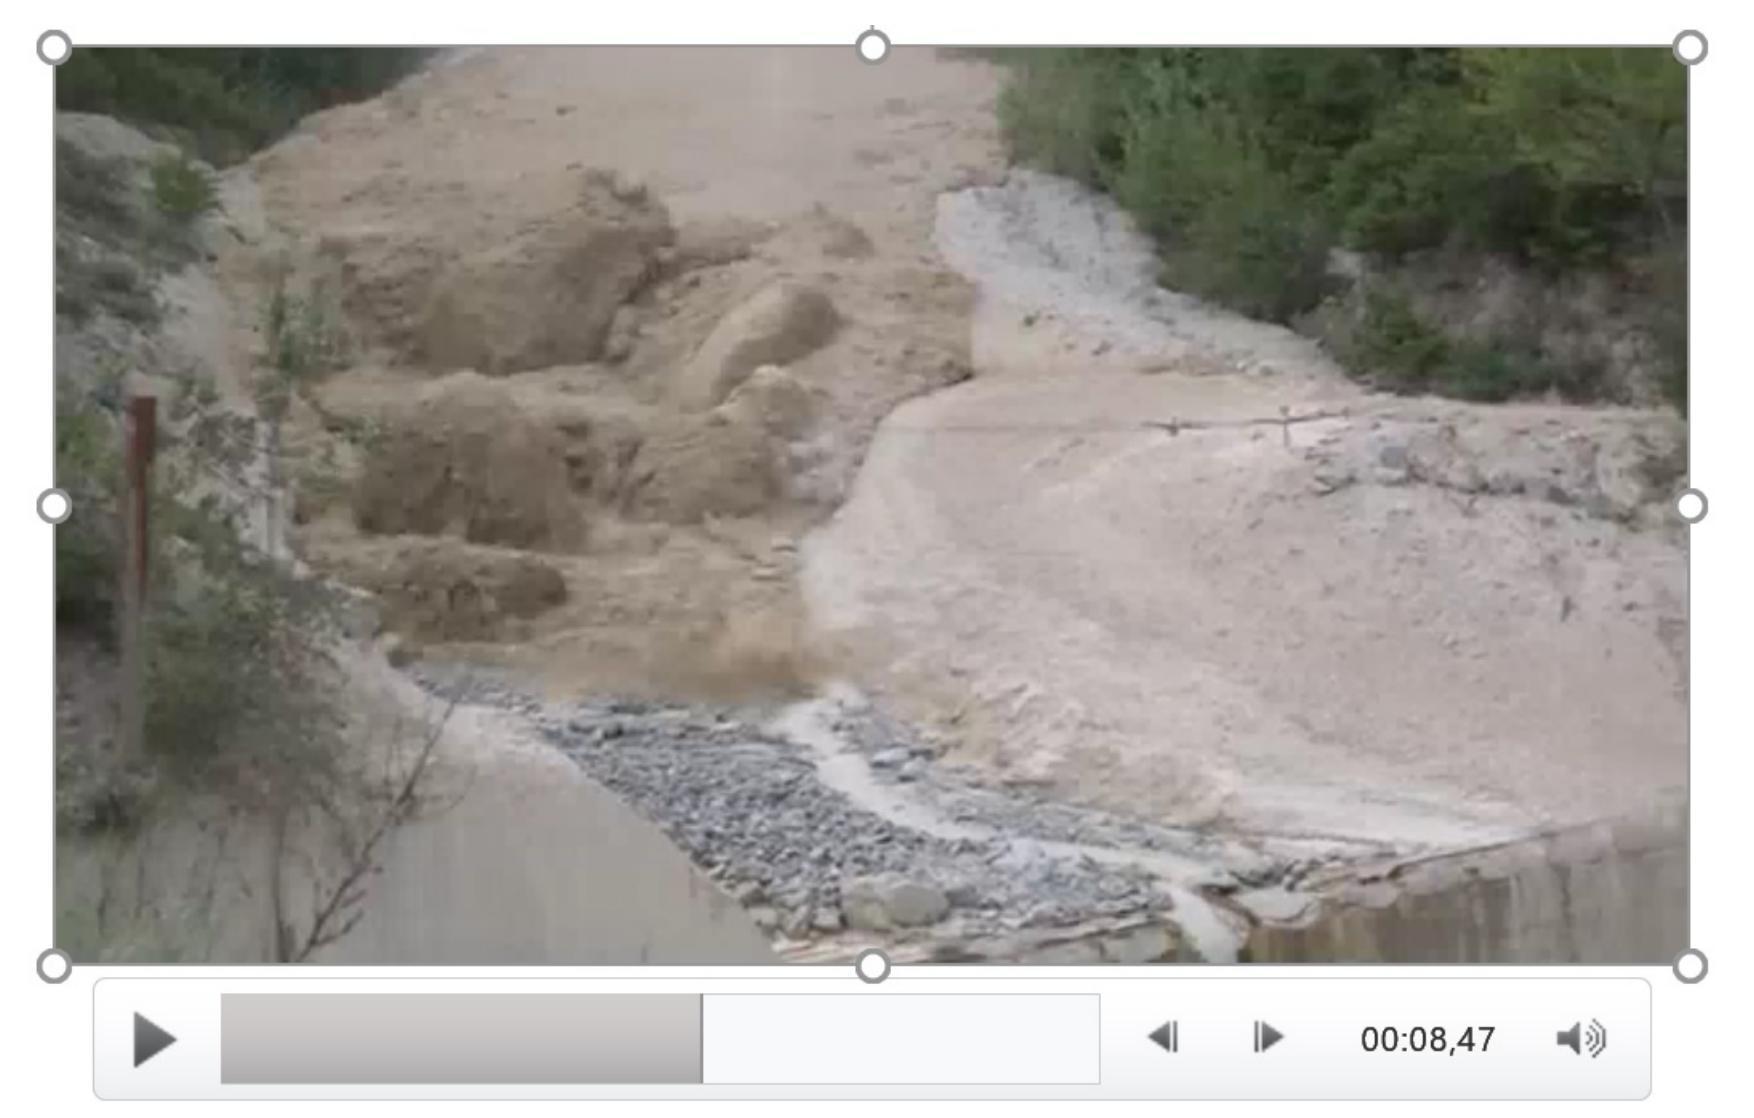
The force plate before and after the debris flow

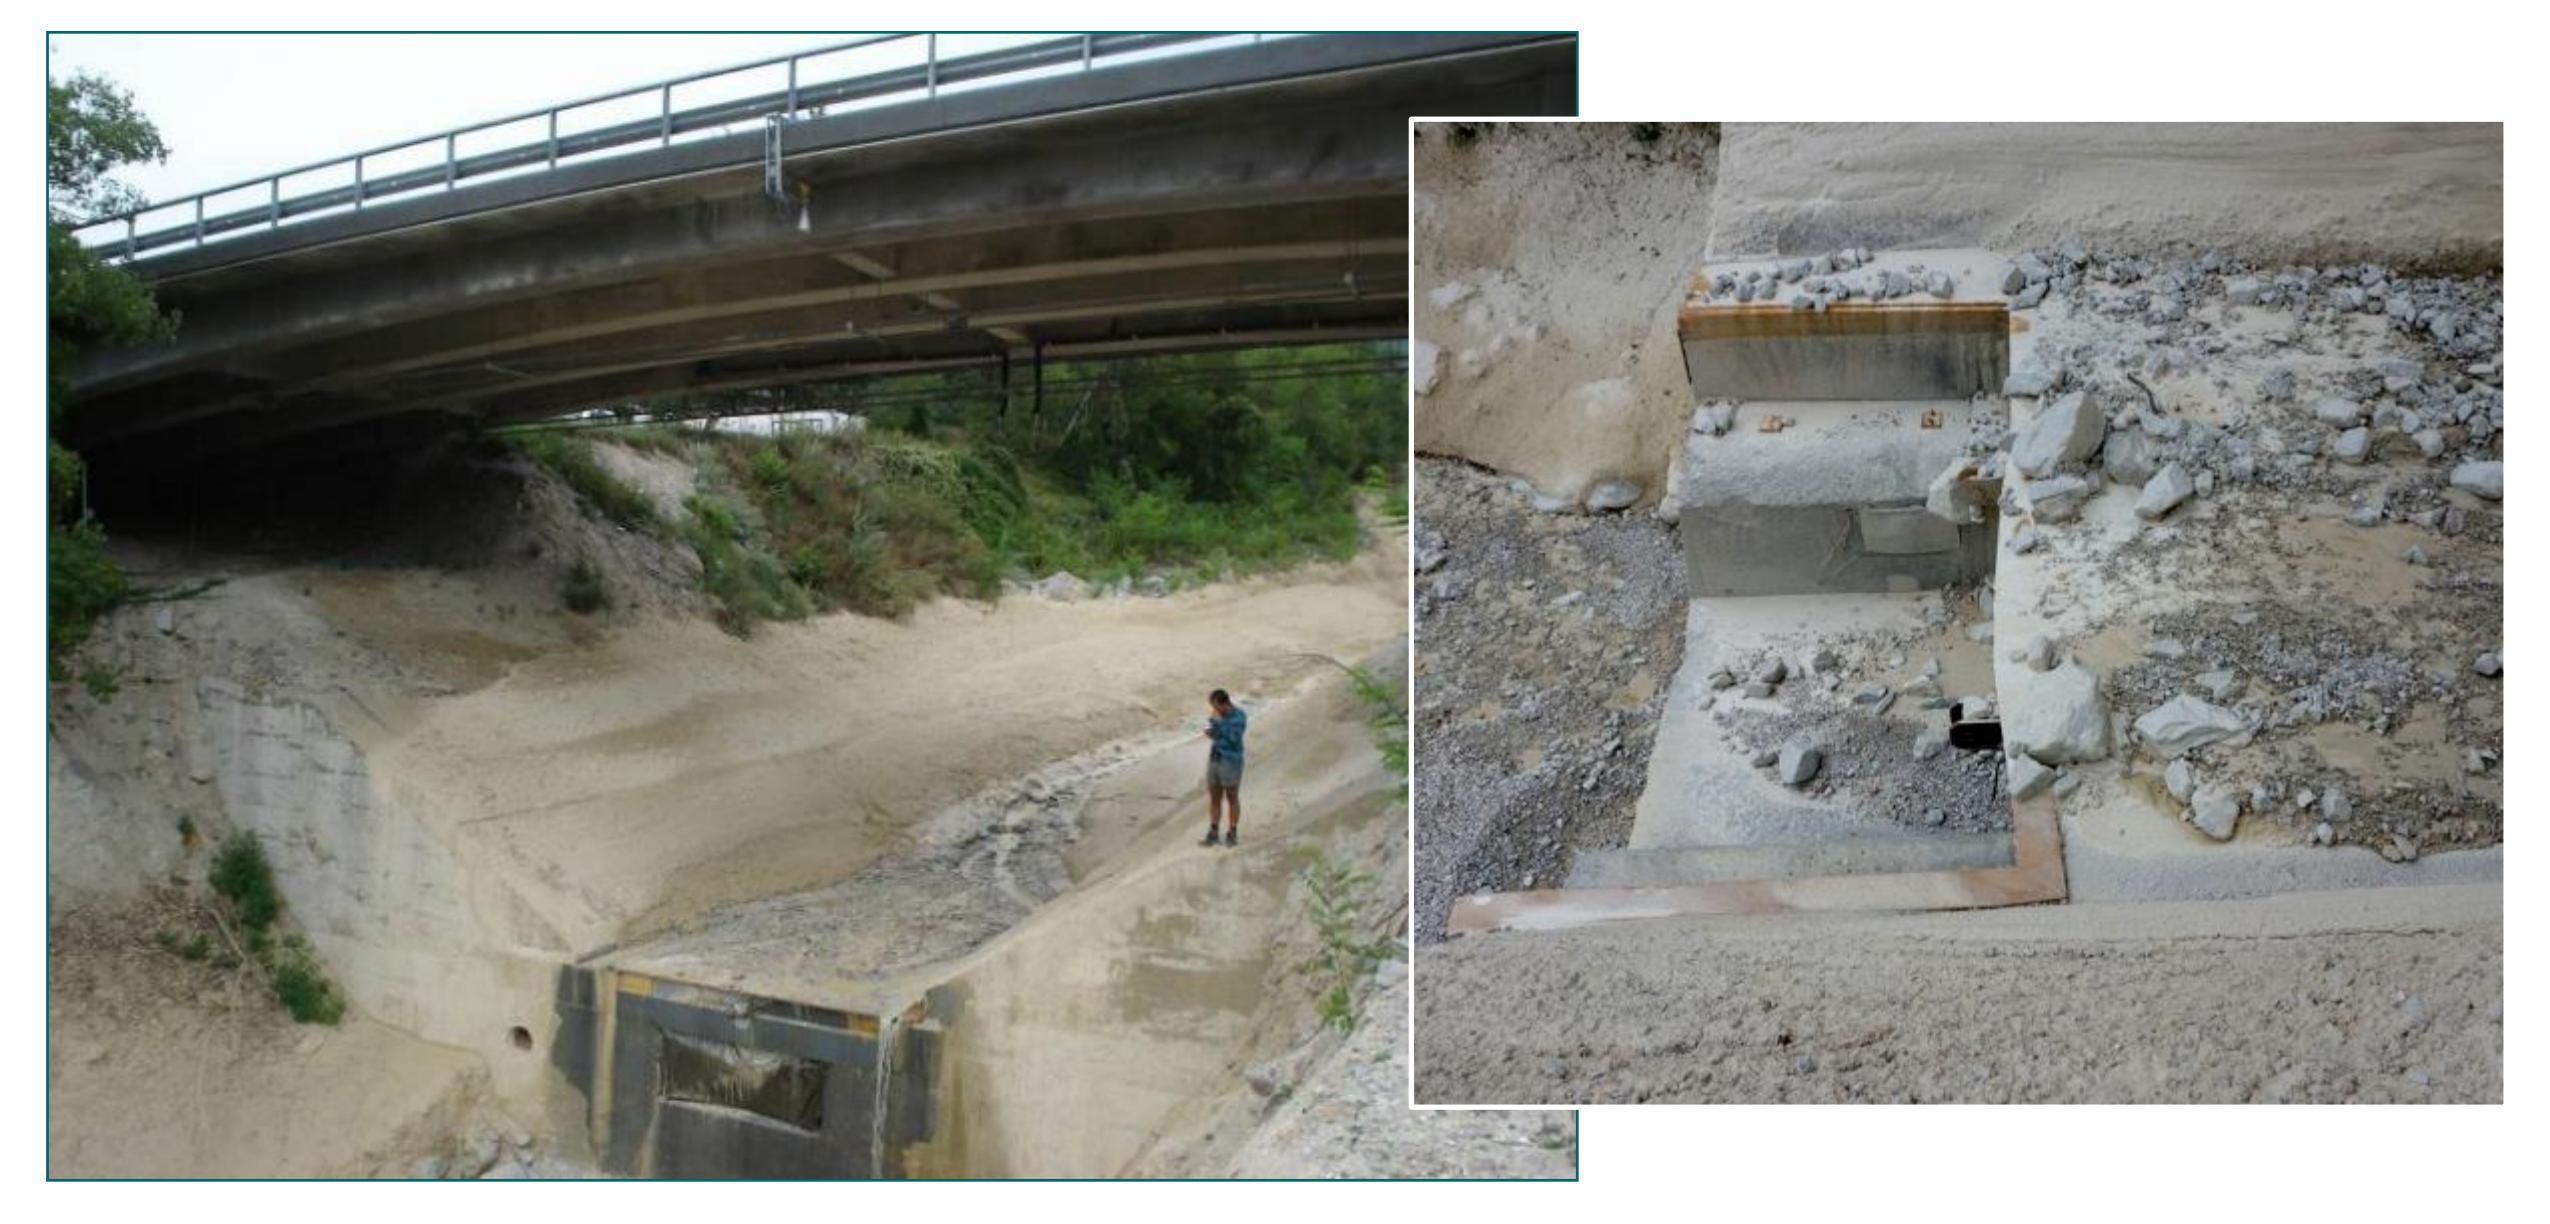
Destruction of the force plate on 22.07.2016
