An Analysis of the 2017 Rock Avalanche and Debris Flows at Pizzo Cengalo, Switzerland (with a short update on the Illgraben force plate)

Brian W. Mc Ardell with contributions from: S. Demmel, M. Christen, P. Baer, F. Frank, P. Molnar, P. Bartelt, F. Amann,

Swiss Federal Institute for Forest, Snow and Landscape Research

Early warning systems for debris flows: state of the art and challenges Bozen-Bolzano, October 16-18, 2019

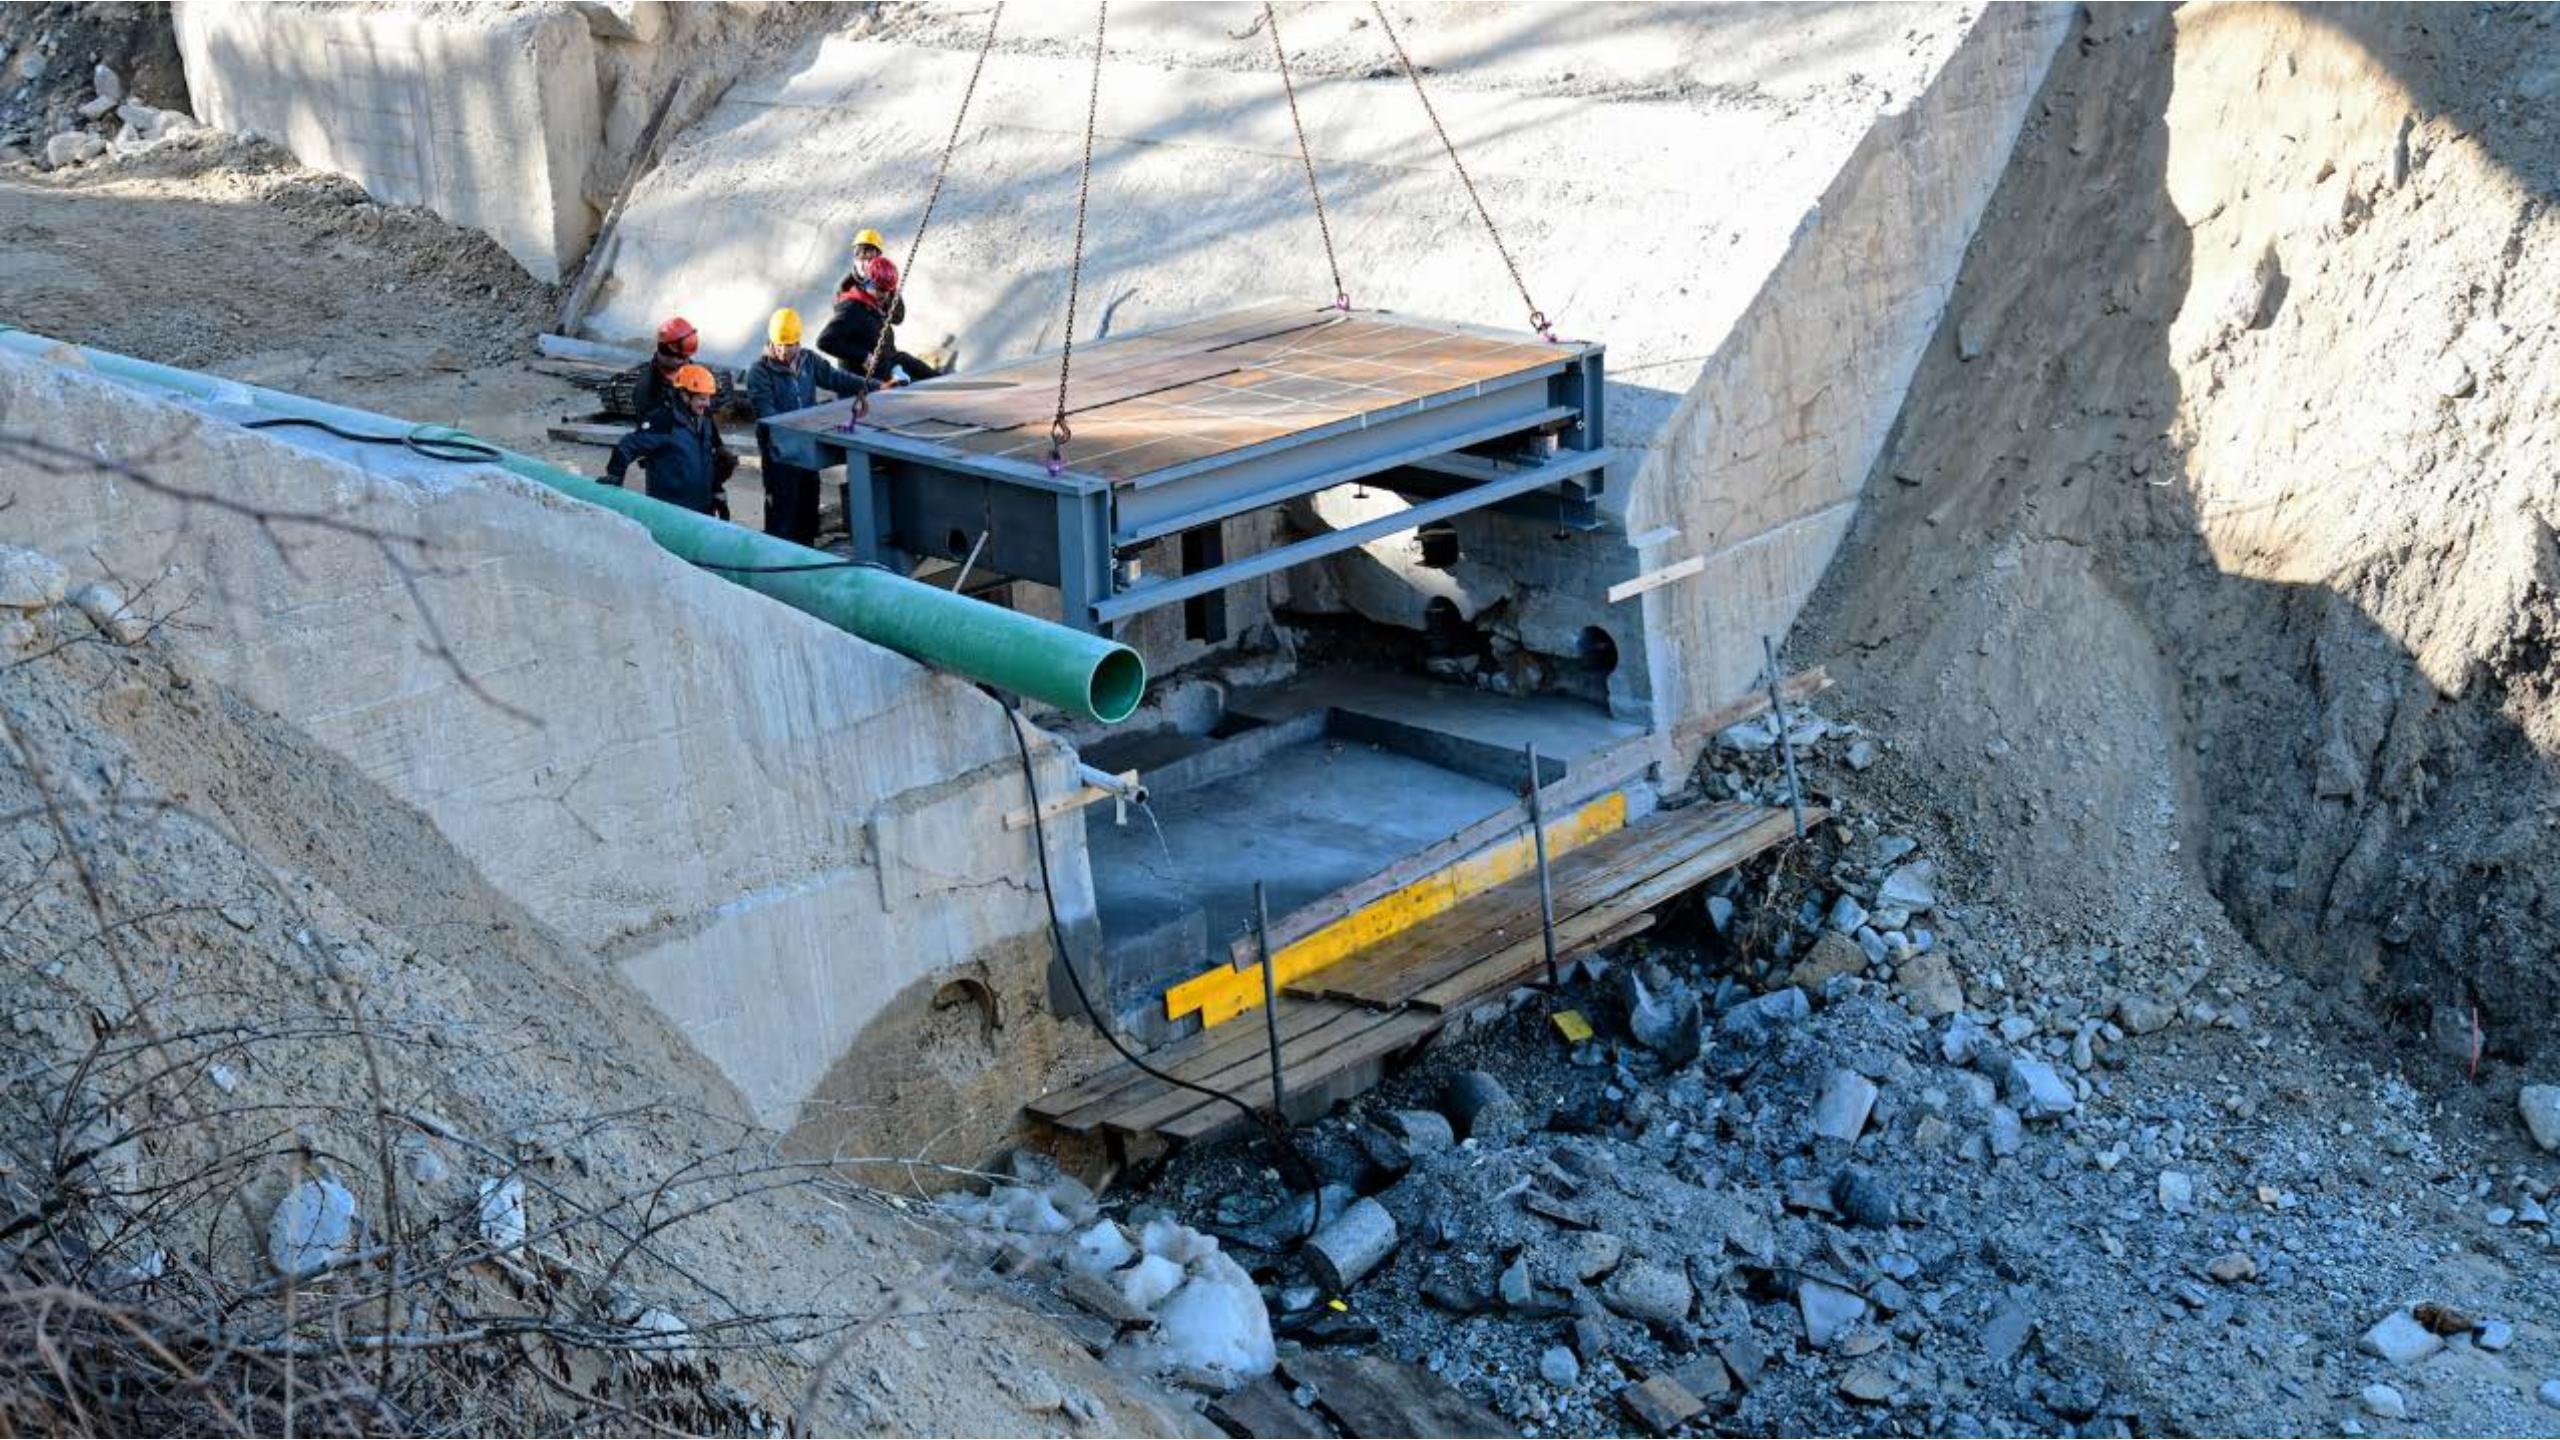
Designed a new and Improved force plate Installed February 2019

Calibration March 2019 For horizontal and normal forces
